# Temporary jetting pump cleans mooring at popular yacht club

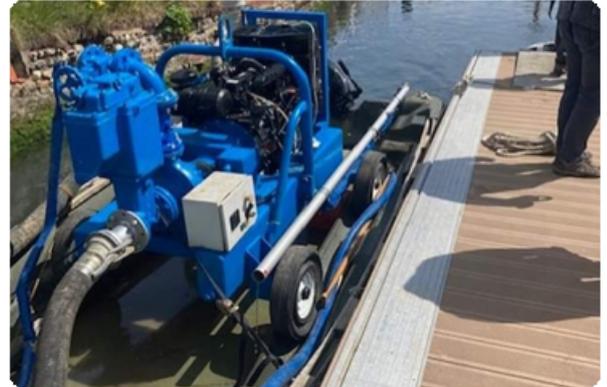
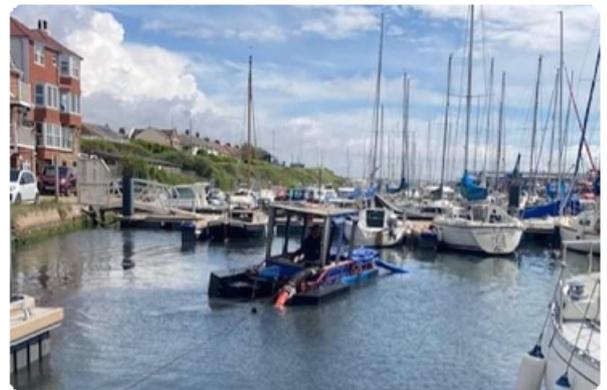
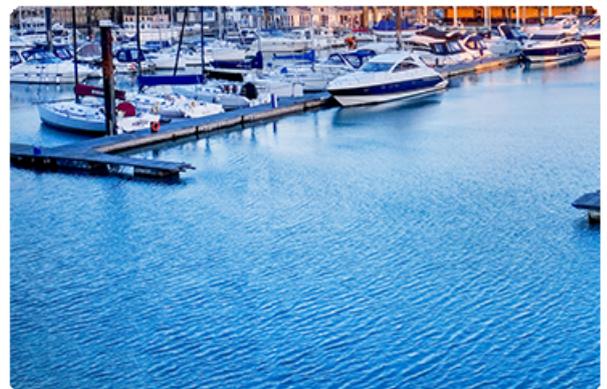
Following the enquiry, our local expert based in the region conducted a site survey before presenting a solution that would facilitate maintenance of the affected moorings. We proposed the use of our 4" HP100 pump, which the client loaded on to a barge that was being used to access all parts of the site.

With dredging work of this nature, it is important to ensure the barge was of the right size to safely accommodate the working load of our pump. We have provided similar jetting solutions on previous occasions, with the suction hose drawing water directly from the sea.

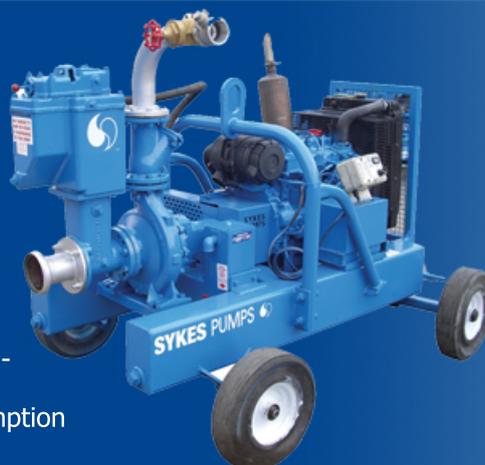
**Performance** Max head:- 98 m  
Max flow:- 44 l/s  
**Weight** 1004 kg with fuel  
907 kg without fuel  
**Dimensions** 1940 x 1450 x 1530 MM  
**Noise level** @ 7m = 77 - 82 dBA  
Fuel capacity 122 litres  
**Pipe connections Suction:-** 4" Table D  
or 4" Bauer  
**Discharge:-** 2 1/2" Instantaneous adapter  
or (3" Bsp)  
**Fuel Consumption** Full load @ 2800 rpm:-  
10.8 litres/hour  
**Energy Efficient duty point** Fuel Consumption  
@ 2500 rpm:- 7.7 litres/hour
